**CALIFORNIA DEPARTMENT OF FORESTRY AND FIRE PROTECTION  
NEVADA-YUBA-PLACER UNIT**  
13760 Lincoln Way  
Auburn, CA 95603

## **INVESTIGATION REPORT**

<b>INCIDENT NUMBER:</b>	17-CA-NEU-026269
<b>CASE NUMBER:</b>	17-2320-122
<b>CASE NAME:</b>	CASCADE
<b>DATE:</b>	October 8, 2017
<b>INCIDENT TYPE:</b>	Wildland Fire
<b>INCIDENT INVESTIGATORS:</b>	Mike RUFENACHT, Battalion Chief – NEU Chris VAN COR, Division Chief –SAC Karen VILLALOBOS, Battalion Chief - SAC Jeremy MONROE, Deputy Chief– SAC

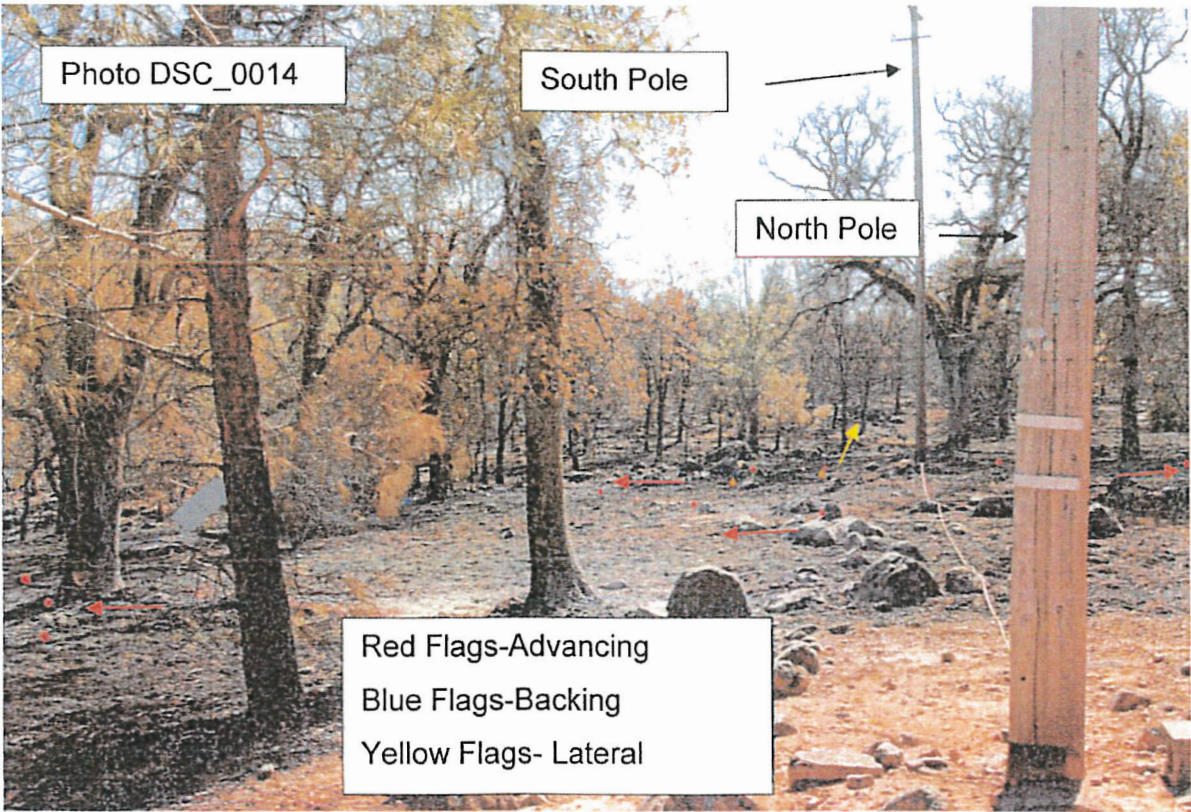
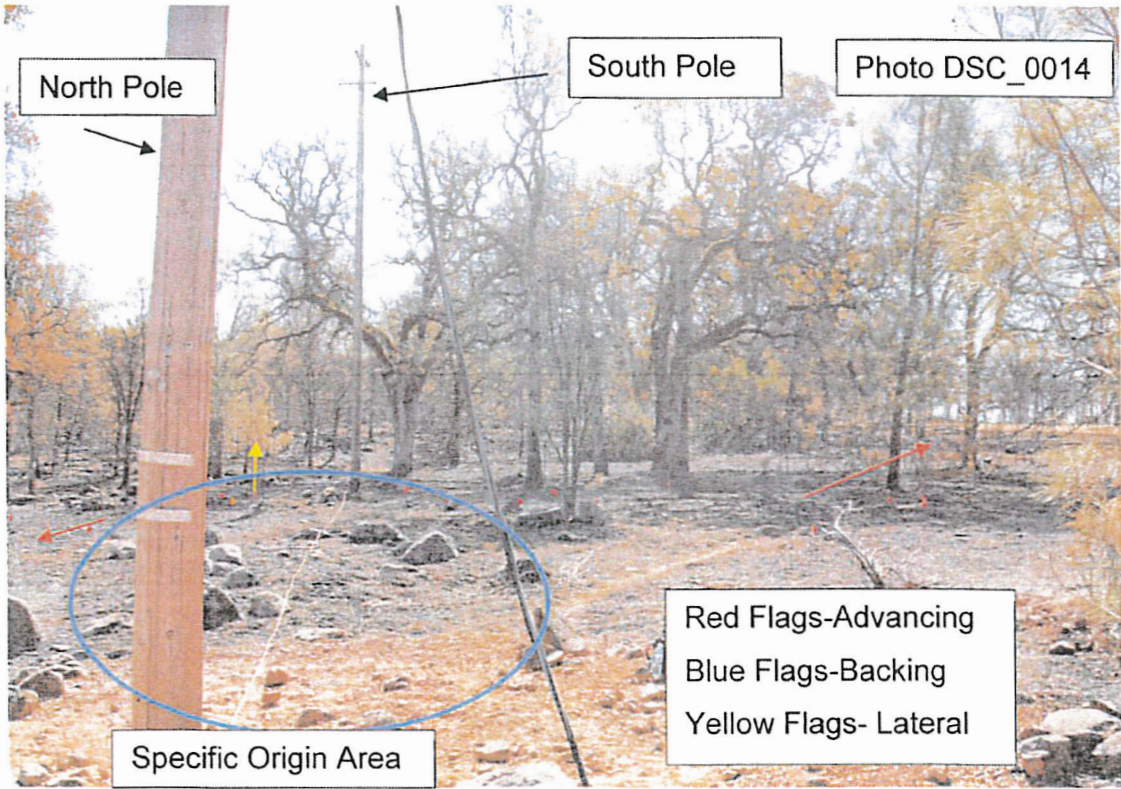
9 On Friday October 13, 2017 at 10:15 AM I arrived with Jim NOLT (J H Nolt  
10 Associates Electrical, Mechanical, and Corrosions Engineers) and BARCKLAY at 13916  
11 Cascade Way. I continued adding fire pattern indicator flags, and verified the fire pattern  
12 indicator flags VILLALOBOS and MONROE had placed indicating the GOA. The fire  
13 pattern indicator flags underneath the north and south utility poles on the RIDDLE  
14 property showed advancing fire indicators going away from the area below the  
15 conductors in the dead and dry annual grasses. This area was identified as the Specific  
16 Origin Area (SOA).

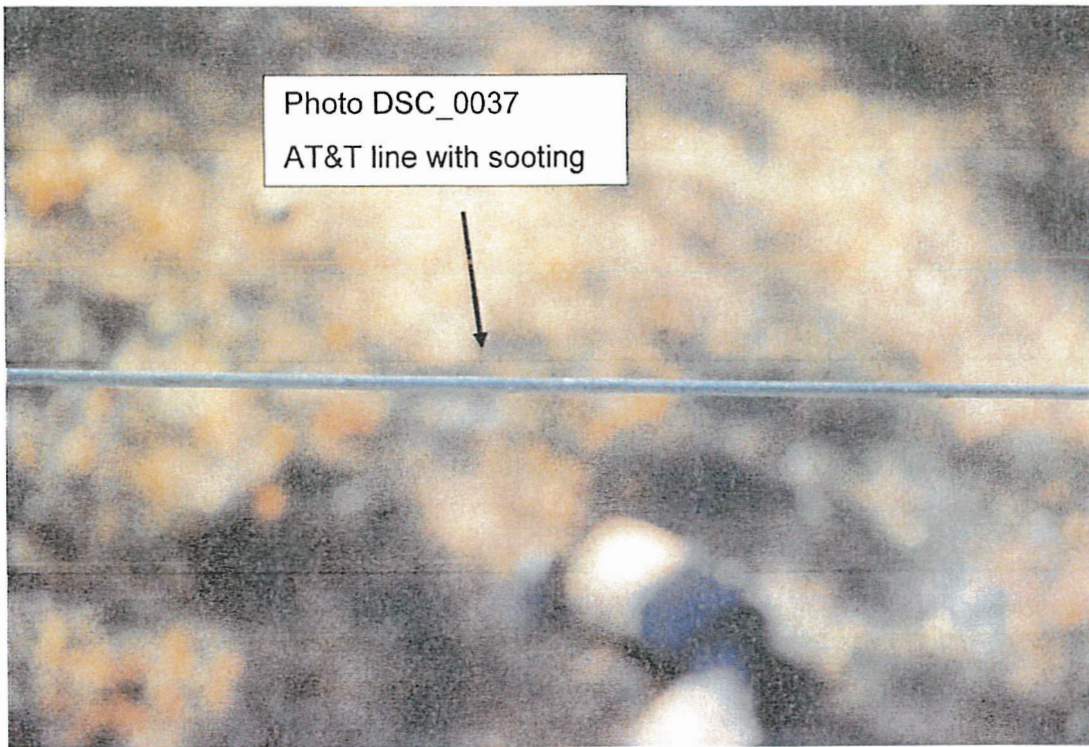
2 Examining the PG&E conductors the from the bucket truck, I observed sag in the lines.

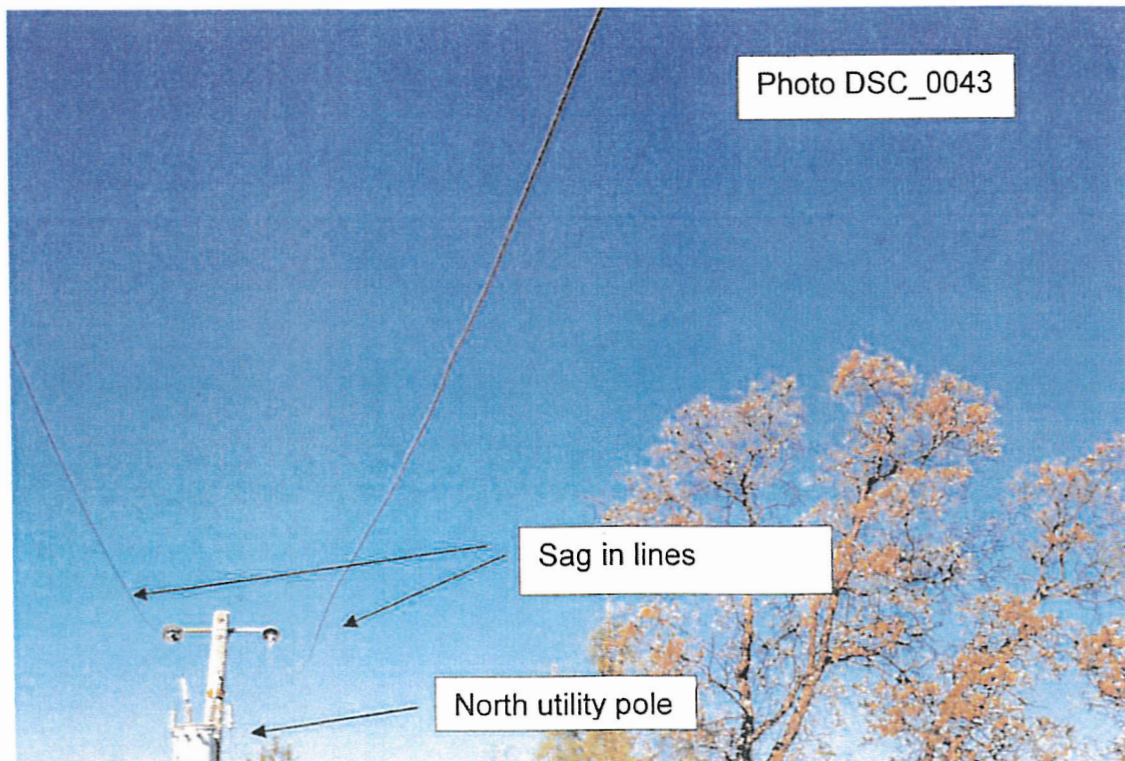
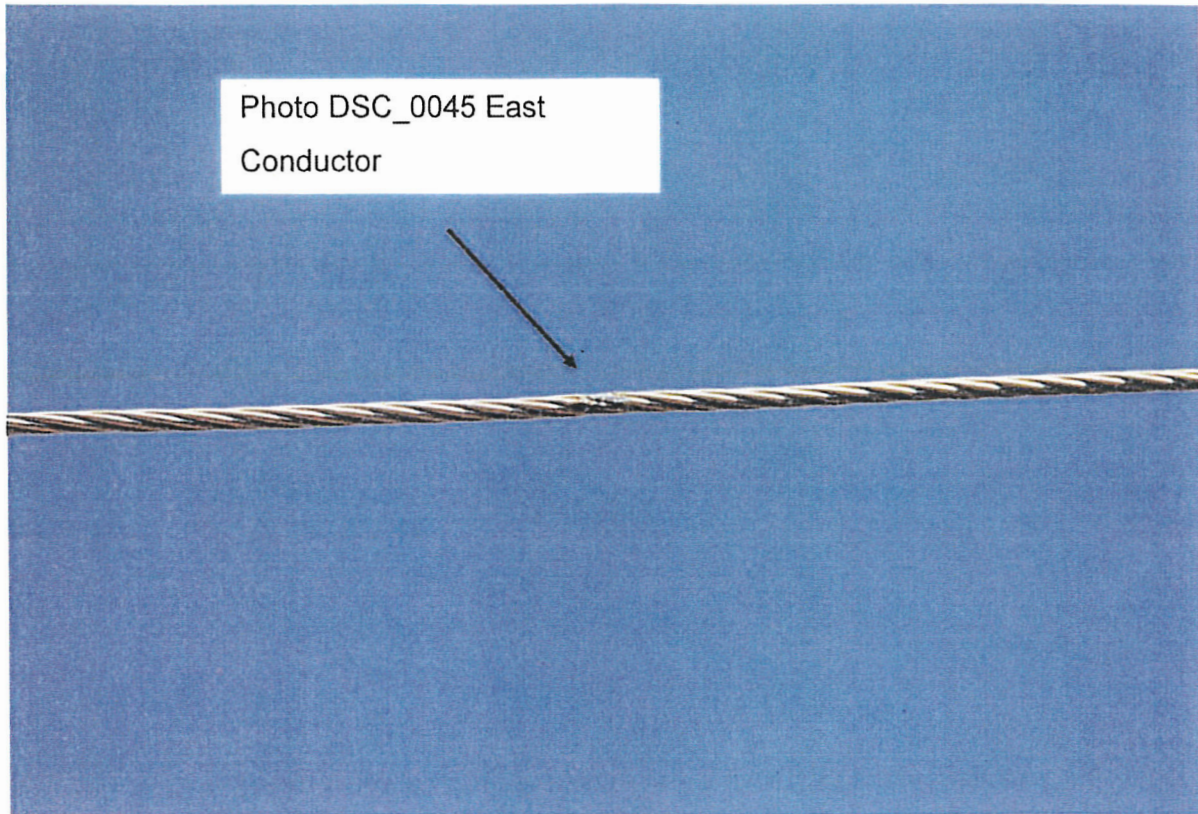
1 From the bucket truck, I observed and photographed an irregularity on both the east  
2 and west conductors. The irregularities appeared to be damage to the lines. The  
3 damage appeared to be close to the same distance between the north and south utility  
4 poles. Jim NOLT completed an independent report of the electrical equipment at the  
5 scene (Attachment -7).

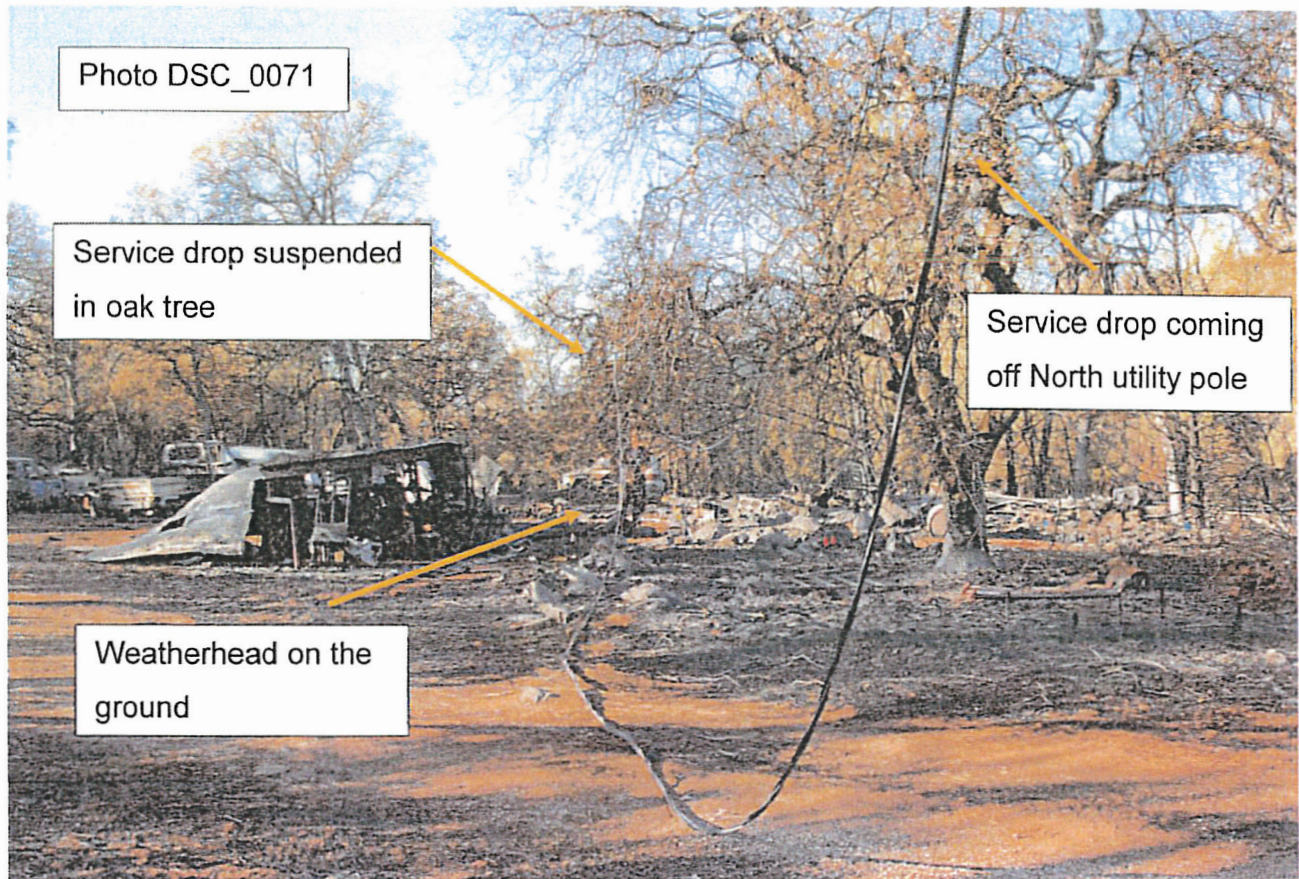
1  
2 I was unable to locate any tree branches on the drop line which would suggest the tree  
3 caused the drop line to contact the ground. I was unable to locate any limb damage,  
4 charring, pitting, or staining on the tree which would have been indicative of a live  
5 conductor making contact with the tree. The weatherhead, electrical meter, and  
6 electrical panel to the 5<sup>th</sup> wheel trailer were collected as evidence and sent to Anamet  
7 Inc. for further laboratory testing due to the extent of fire damage to the equipment.  
8 NOLT also looked at this equipment for analysis (See NOLT report - Attachment 7).

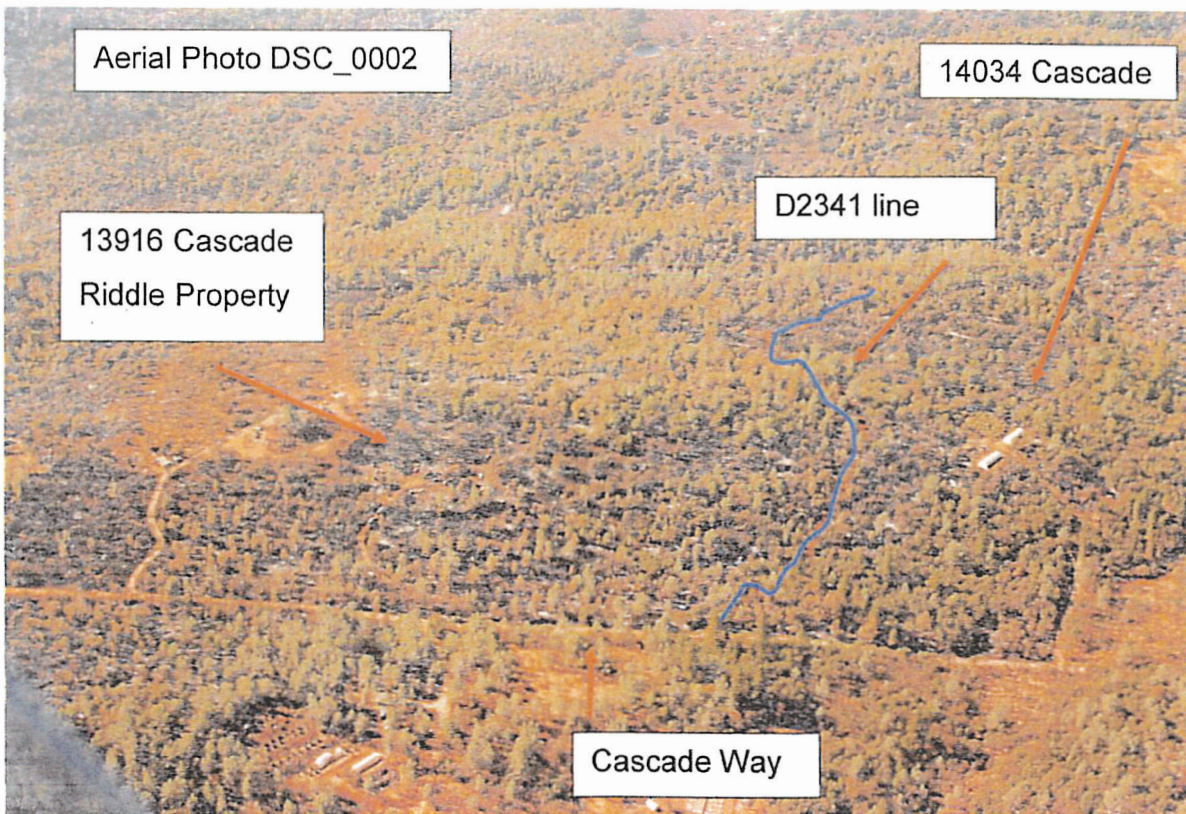
12 dozer line near 14034 Cascade. ROGERS said he was cutting direct line. the  
13 Marijuana cultivation buildings and power pole at 14034 Cascade Way were not  
14 involved in fire until suppression crews arrived and used fire to improve the line (See  
15 Aerial Photo DSC\_0002).

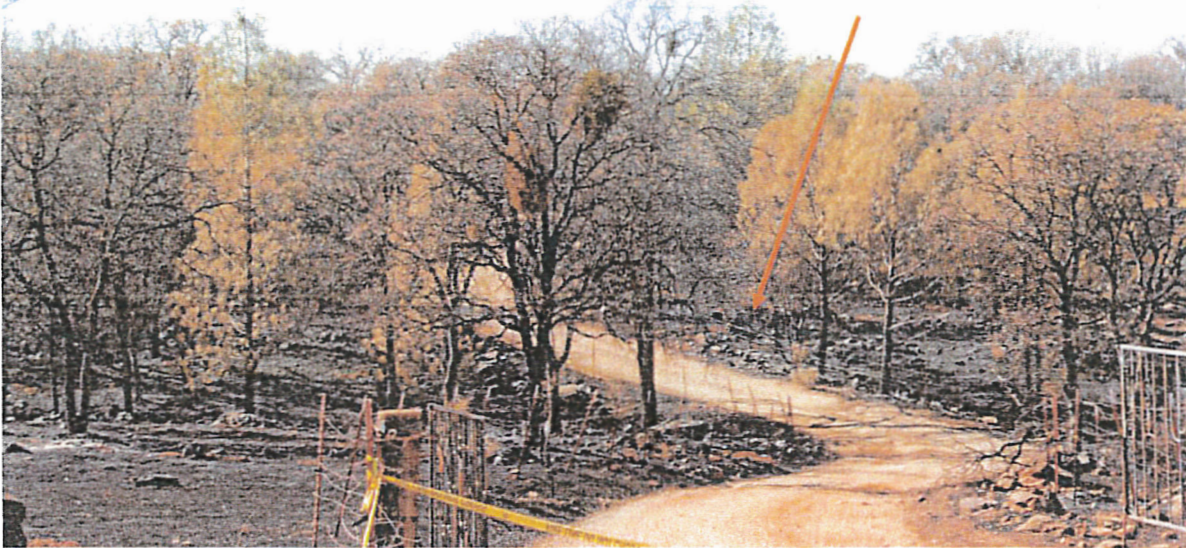
Photo DSC\_0085-Taken by DANILYAN

At about 9:20 AM on Saturday October 14, 2017, I interviewed Greg DANILYAN at his residence at [REDACTED] (See Attachment 9) . DANILYAN said the fire was on the north side of the JOHNSON driveway, and had not crossed to the south side of the driveway. DANILYAN said the fire was about 100-200 feet from Cascade Way. DANILYAN did not give a size of the fire, and I asked him if it was windy and his response was "insanely windy". DANILYAN had to leave but met me again at the property at about 2:00PM. I gave DANILYAN my camera and asked DANILYAN to take a picture of where he saw the fire the night of October 8, 2017 when he was driving out. DANILYAN took a picture of the driveway to Matt and Jennifer JOHNSON's house. I asked DANILYAN if he drove through smoke on his way out on October 8, 2017 and DANILYAN said "no". The photo DANILYAN took is DSC\_0085, taken from Cascade Way looking west.

Driveway at [REDACTED] (JOHNSON property)
