INVESTIGATION REPORT

CASE NUMBER:	17CABTU015954
CASE NAME:	La Porte
DATE:	October 8, 2017
INCIDENT TYPE:	Vegetation Fire
INCIDENT INVESTIGATOR:	Tom Kluge – Fire Captain Specialist - BTU

LA PORTE FIRE

17CABTU015954-103

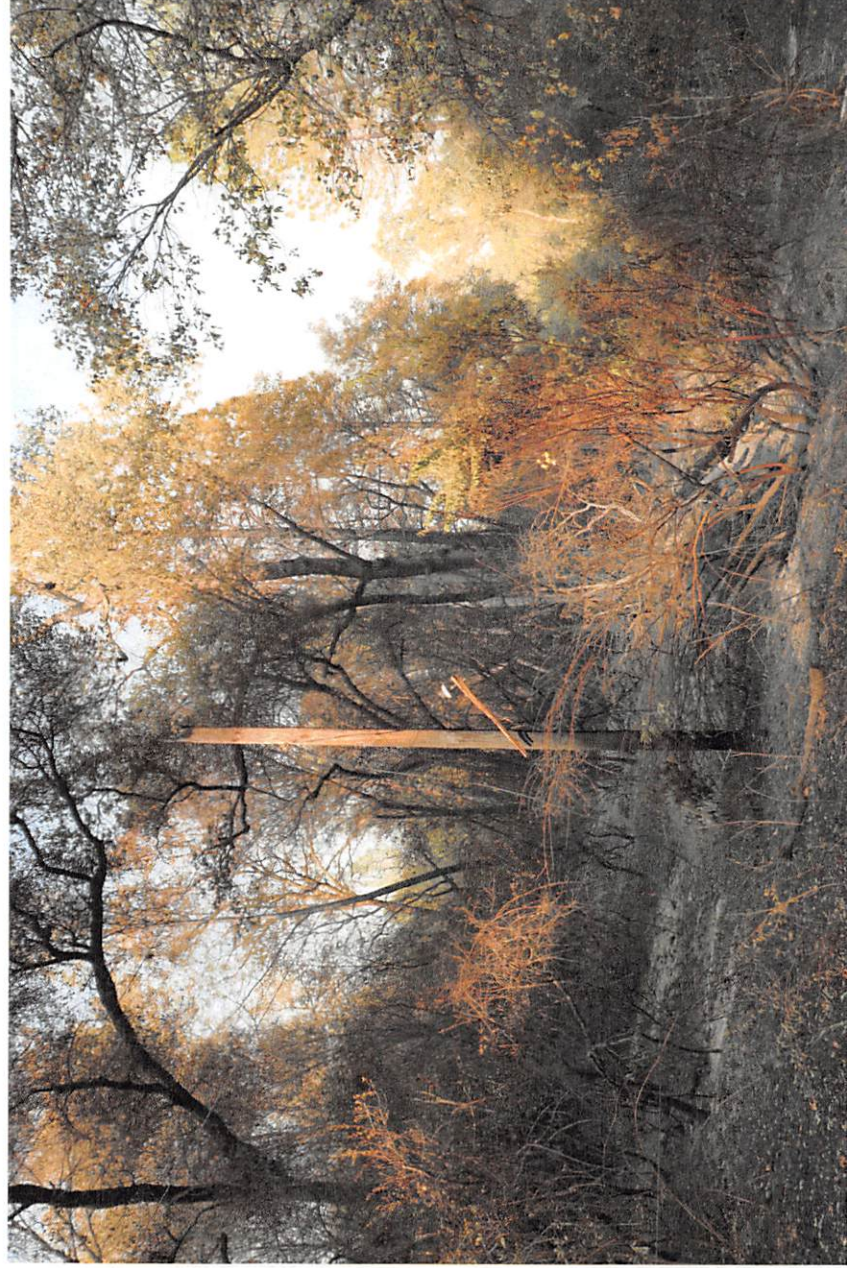
Photograph 1
General Origin Area (GOA)

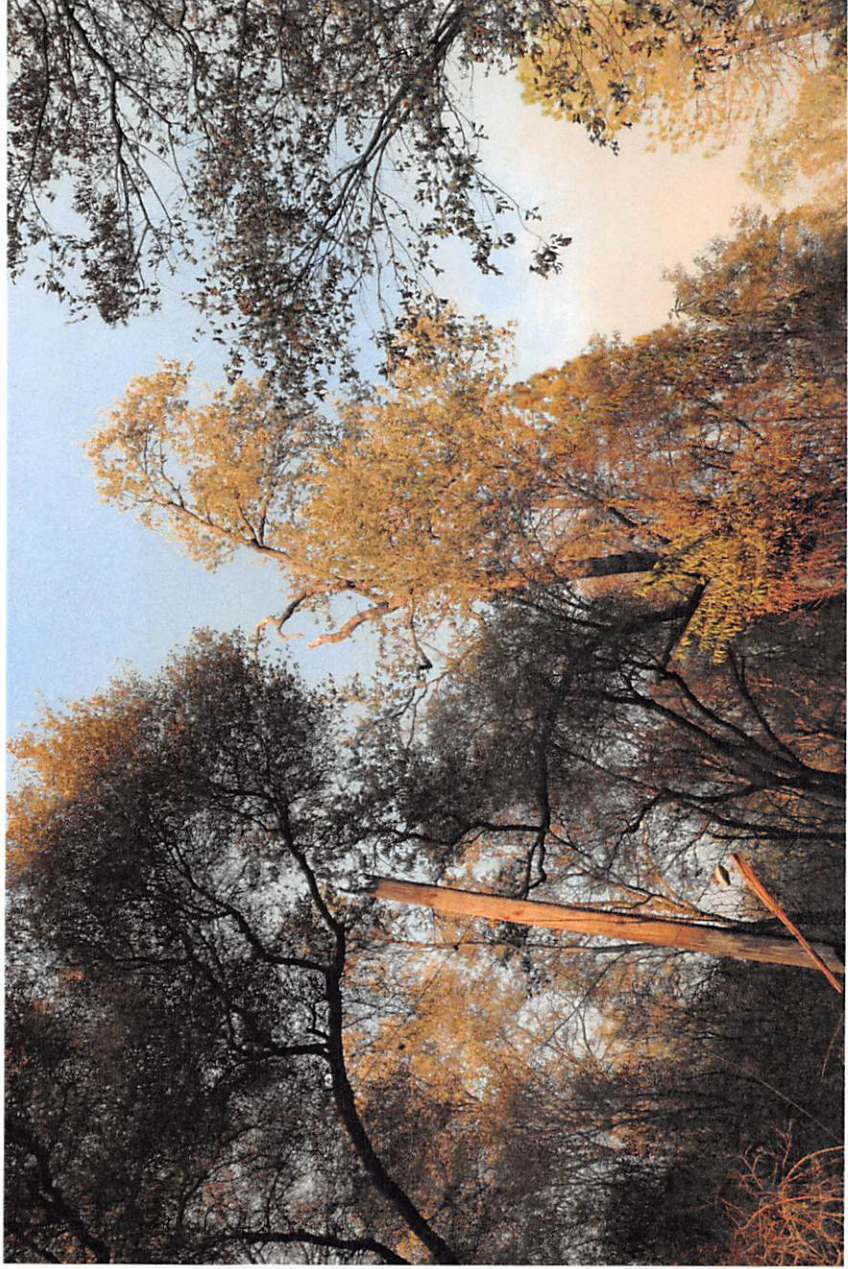
Photograph 2
Subject tree in GOA

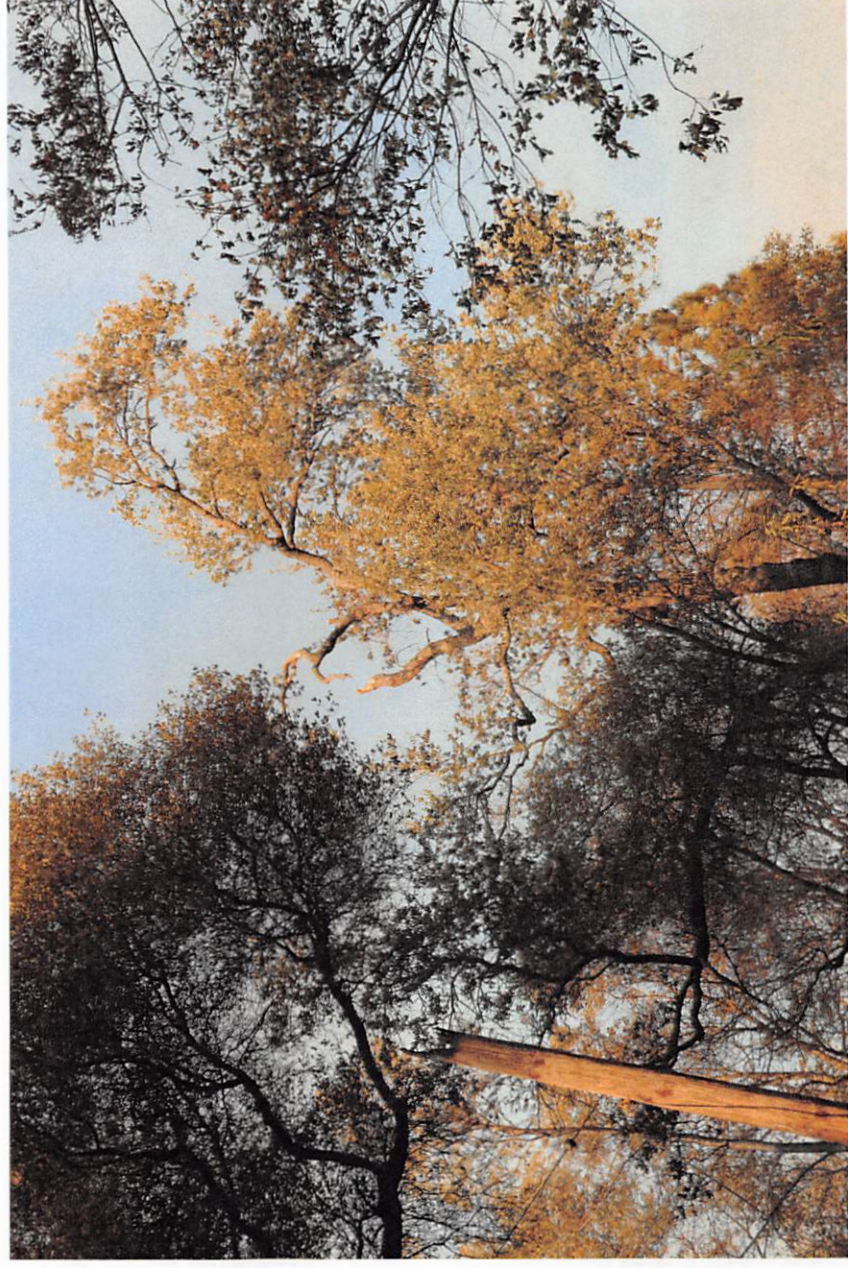
Photograph 3
Closer view of subject tree in GOA

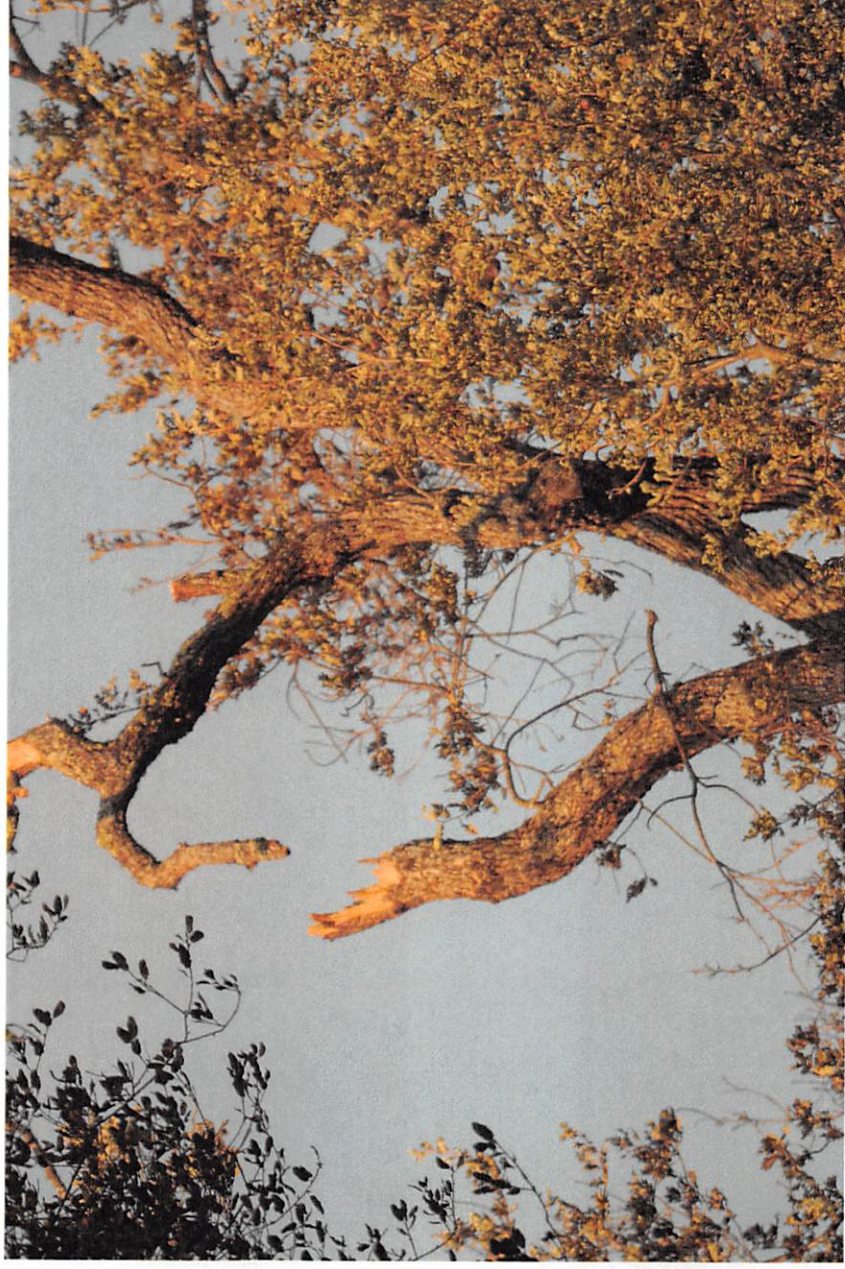
3
4 The report provided by the contracted arborist, Mark Porter, stated the subject valley
5 oak did show signs of decay. The arborist report stated there may have been a crack at
6 the base of the limb. The arborist report stated it is possible there were no visible
7 outward signs of failure or weakness that would have been discovered with a normal
8 assessment.

Photograph 5
Subject limb break of subject tree

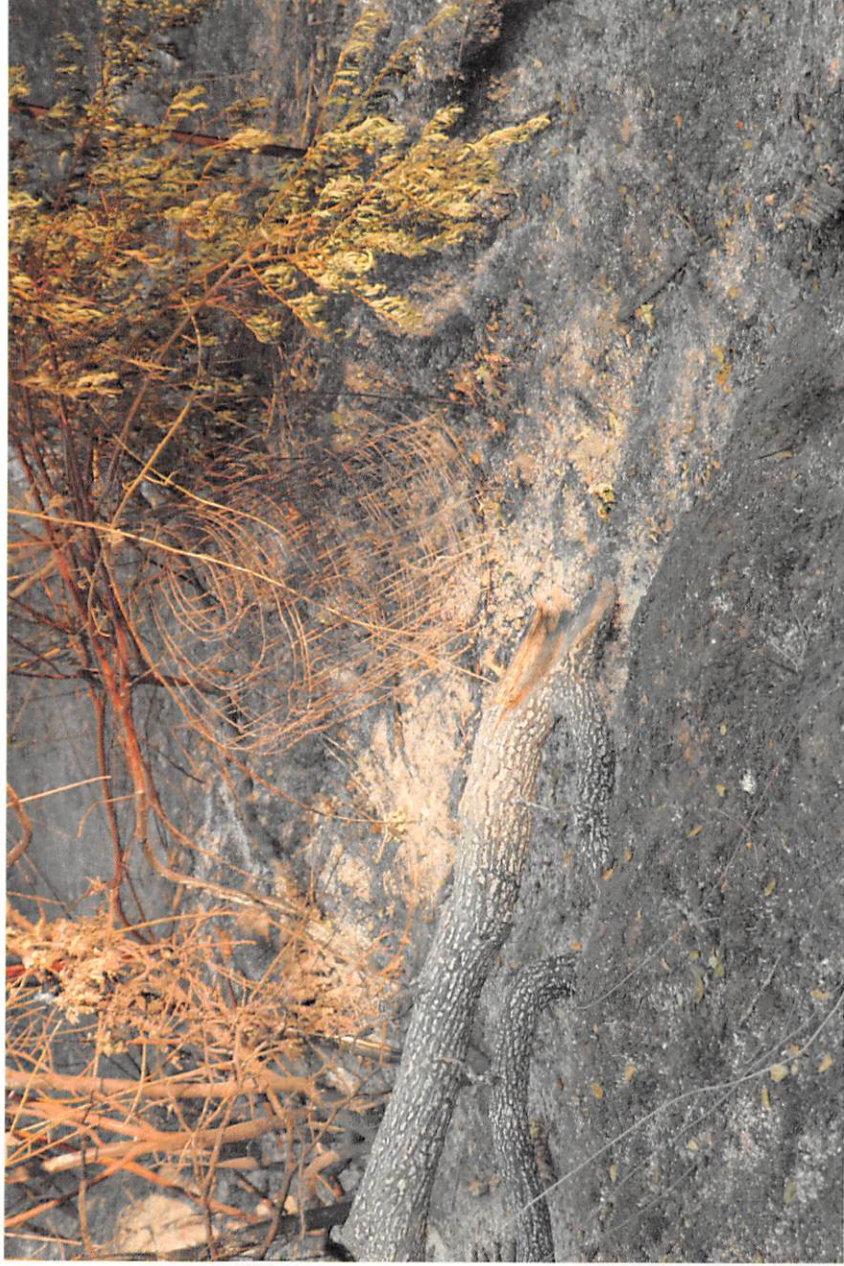
23 (photo 7). I observed the break in the branch did not appear to be weathered. The oak
24 branch was partially scorched however mostly undamaged with leaf foliage still intact.
25 The oak branch was positioned on top of the conductor wire that was observed in the
26 SOA. I photographed the area and secured access to the GOA.

Photograph 7
Broken oak limb in GOA
