**CALIFORNIA DEPARTMENT OF FORESTRY AND FIRE PROTECTION  
NEVADA-YUBA-PLACER UNIT**  
13760 Lincoln Way  
Auburn, CA 95603

## **INVESTIGATION REPORT**

<b>INCIDENT NUMBER:</b>	17-CA-NEU-026269
<b>CASE NUMBER:</b>	17-2320-122
<b>CASE NAME:</b>	CASCADE
<b>DATE:</b>	October 8, 2017
<b>INCIDENT TYPE:</b>	Wildland Fire
<b>INCIDENT INVESTIGATORS:</b>	Mike RUFENACHT, Battalion Chief – NEU Chris VAN COR, Division Chief –SAC Karen VILLALOBOS, Battalion Chief - SAC Jeremy MONROE, Deputy Chief– SAC

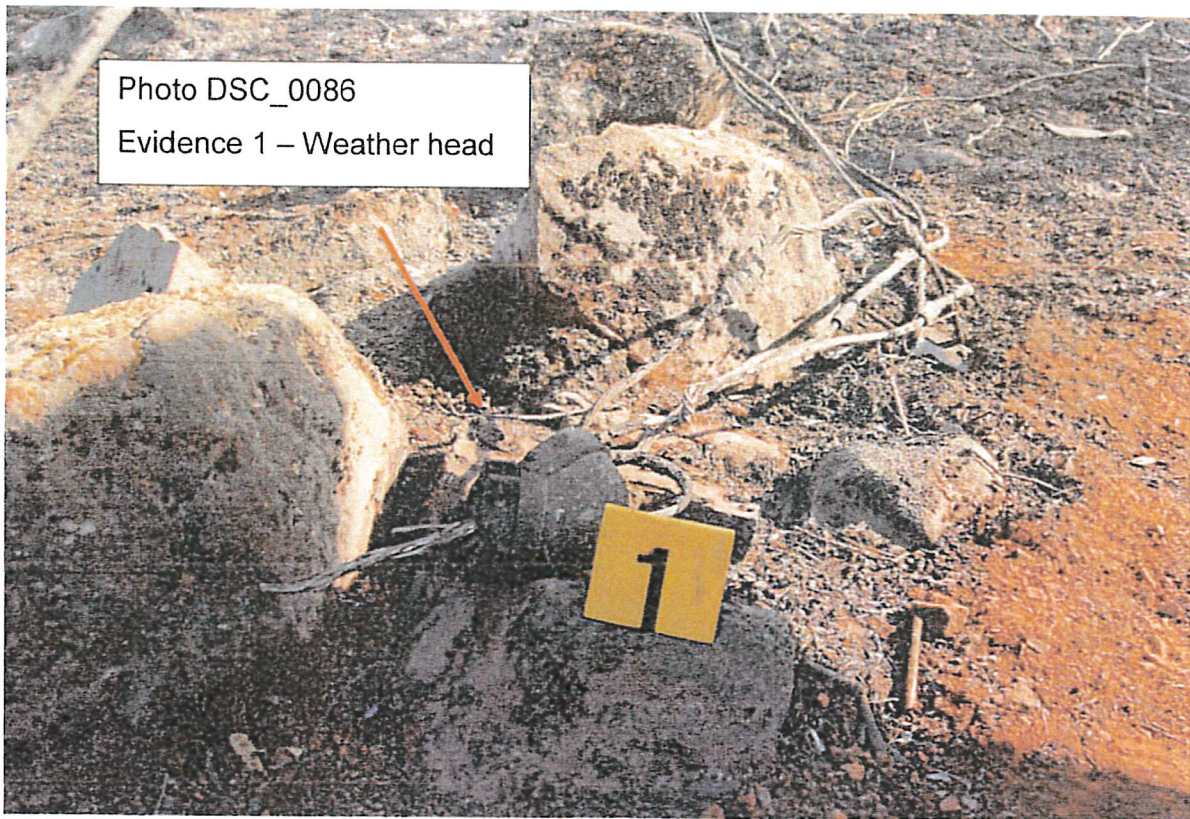
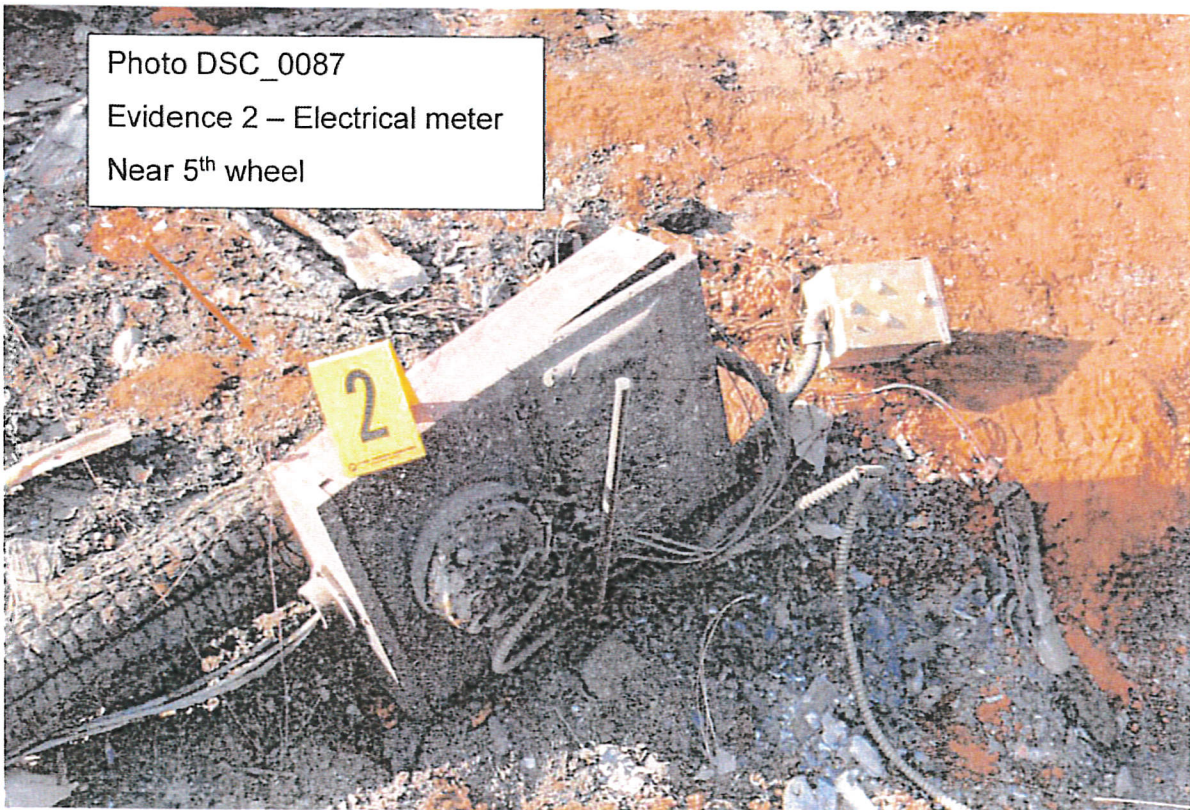
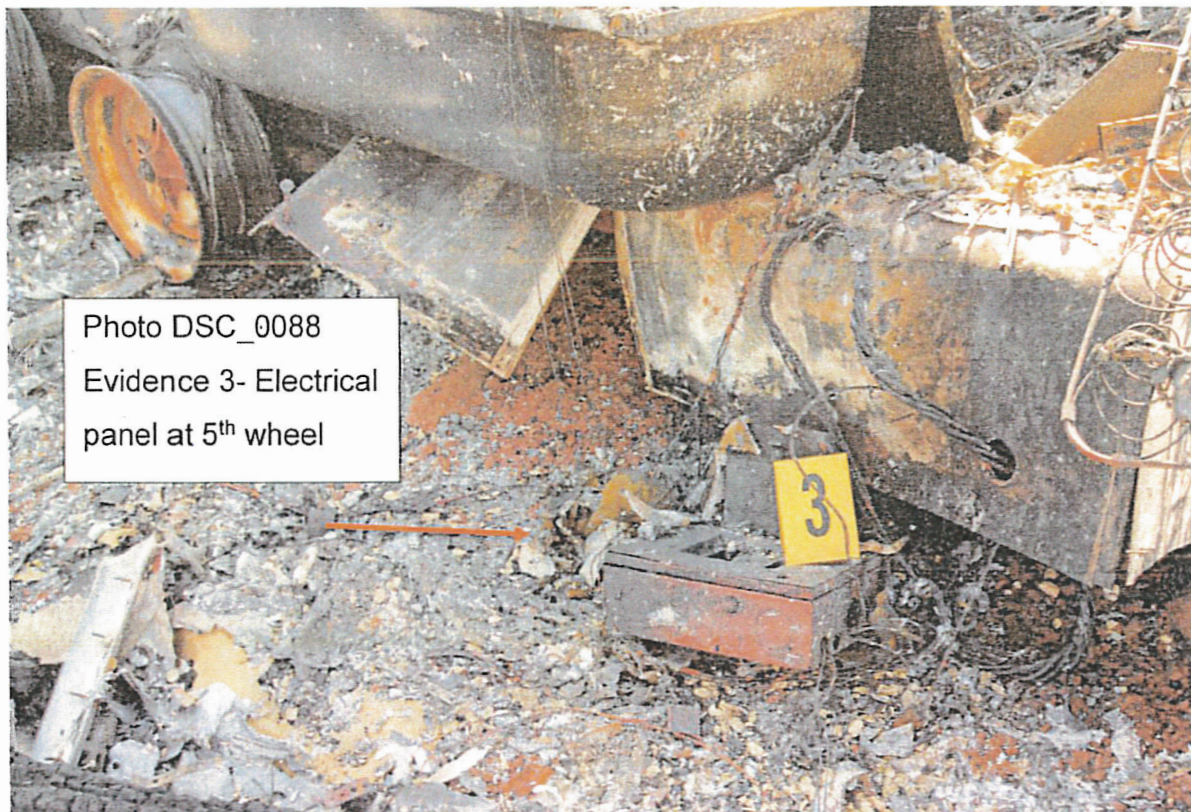
1  
2 I was unable to locate any tree branches on the drop line which would suggest the tree  
3 caused the drop line to contact the ground. I was unable to locate any limb damage,  
4 charring, pitting, or staining on the tree which would have been indicative of a live  
5 conductor making contact with the tree. The weatherhead, electrical meter, and  
6 electrical panel to the 5<sup>th</sup> wheel trailer were collected as evidence and sent to Anamet  
7 Inc. for further laboratory testing due to the extent of fire damage to the equipment.  
8 NOLT also looked at this equipment for analysis (See NOLT report - Attachment 7).

1  
2 Following the wiring from the service drop to the electrical meter, I found wiring going to  
3 the 5<sup>th</sup> wheel and well house on the RIDDLE property. I was unable to locate any wiring  
4 going to the travel trailer or shop on the RIDDLE property.
